AGENDA

7:00 PM REGULAR HISTORIC PRESERVATION COMMISSION MEETING

409 N. Main Street

A
Glossary of
Historic
Masonry
Deterioration
Problems
and
Preservation
Treatments

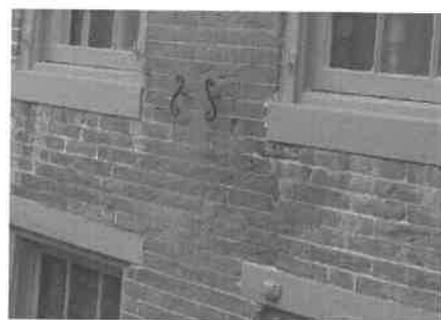
Erosion of the hard surface of this historic brick was the unfortunate (but common) result of sandblasting.

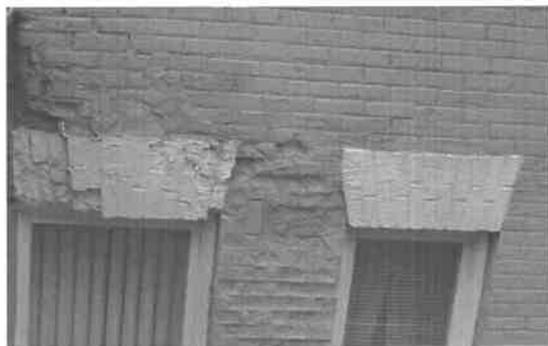
It's easy to see why the owner of this building chose to paint the heavily damaged brick.

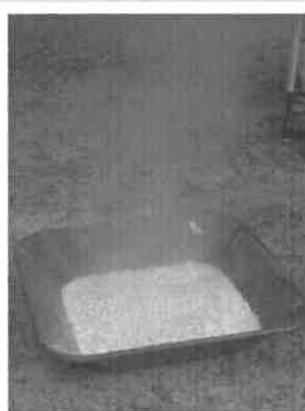
Quicklime slaking after water was added to the pan. Steam rising above the pan was created by the exothermic reaction of the quicklime slaking.

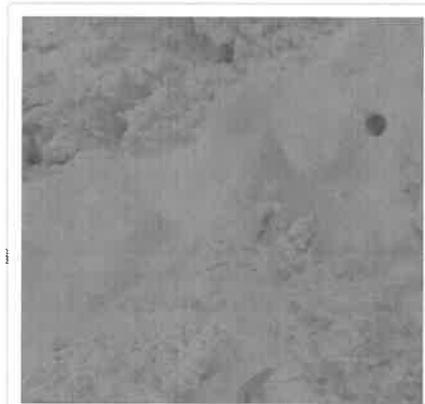
Closeup of quicklime slaking. As water is added the quicklime releases calcium hydroxide is created.

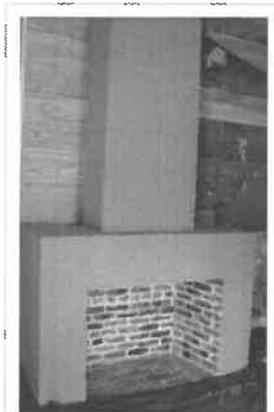
Brick fireplace at Oakland Plantation, part of CAR1, which was limewashed with a colorwash after color analysis. Photograph by Sarah Jackson

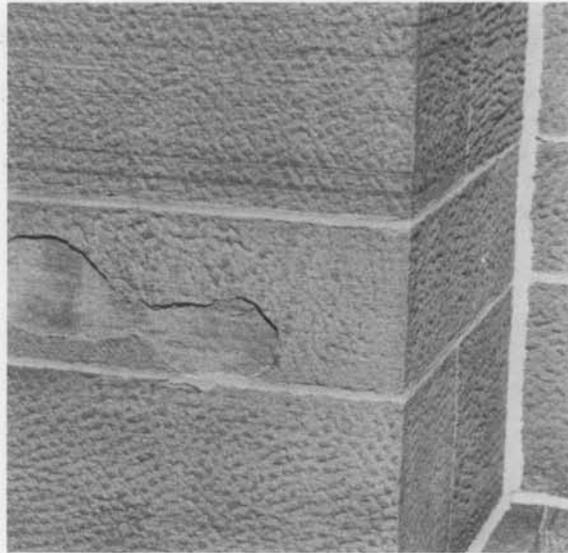
Blistering of sandstone. Photograph: Anne E. Grimmer.

Preservation Treatment: To date, no completely effective treatment has been developed for this condition.

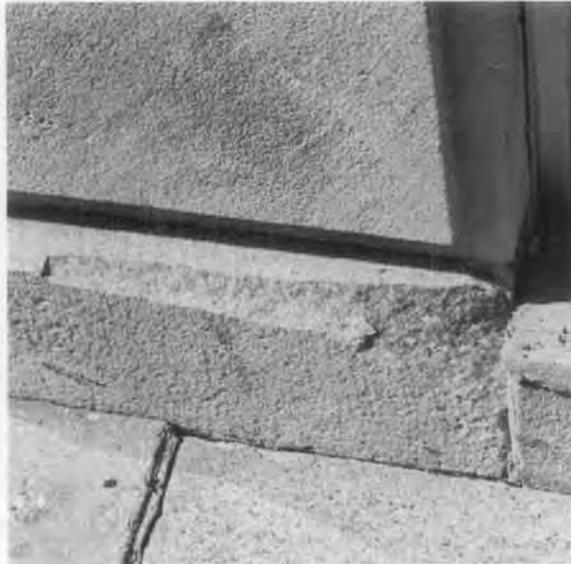
Chipping of granite sill. Photograph: Anne E. Grimmer.

Preservation Treatment: See Dutchman Repair, p.56; Replacement/Patching with Like or Compatible Substitute Materials, p.59.

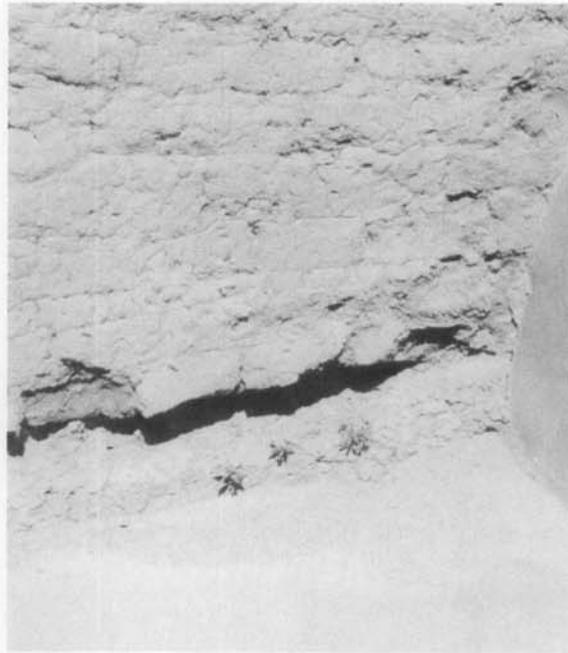
Coving of adobe wall. Photograph: National Park Service.

Preservation Treatment: See Replacement/Patching with Like or Compatible Substitute Materials, p.59.

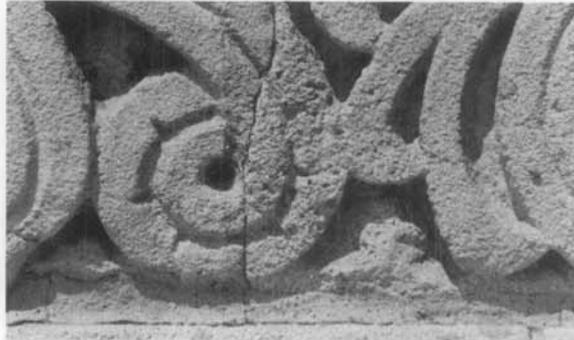
Cracking of limestone. Photograph: John H. Myers.

Preservation Treatment: See Mechanical Repair, p.58; Replacement/Patching with Like or Compatible Substitute Materials, p.59.

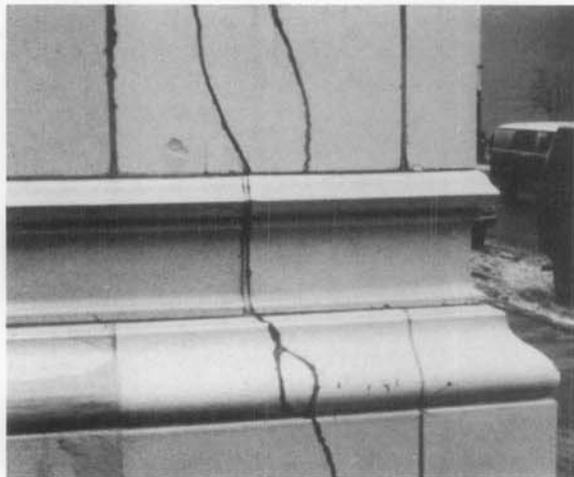
Cracking of glazed terra cotta. Photograph: National Park Service.

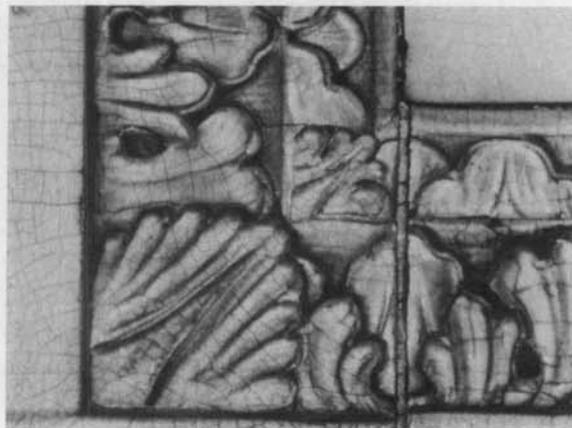
Crazing of glazed terra cotta. Photograph: National Park Service.

Preservation Treatment: To date, no completely effective treatment has been developed for this condition.

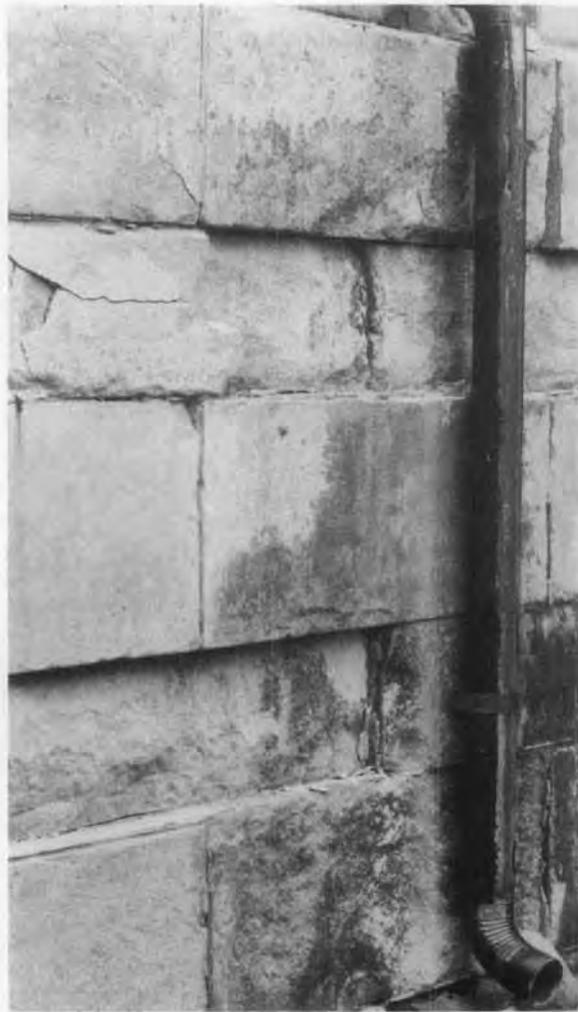
Crumbling limestone resulting primarily from excess moisture penetration. Photograph: National Park Service.

Preservation Treatment: See Consolidation, p.52.

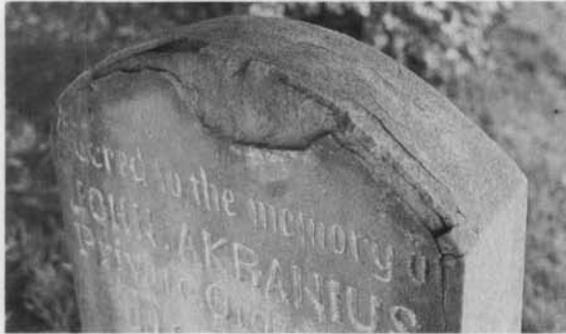
*Delamination of sandstone along the bedding planes.
Photograph: U.S. Corps of Engineers.*

Preservation Treatment: See Stucco, p. 33; Composite Patching/Plastic Repair, p.50; Mechanical Repair, p.58; Replacement/Patching with Like or Compatible Substitute Materials, p.59.

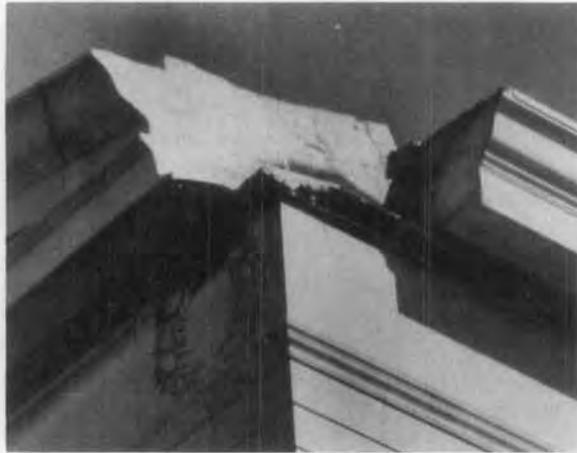
Detachment of section of marble pediment. Photograph: Walter Smalling.

Preservation Treatment: See Mechanical Repair, p.58.

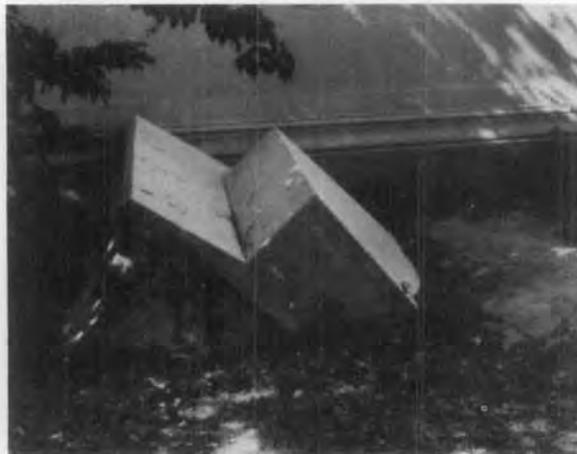
Section of marble lying on the ground at base of building after it had separated from pediment above. Photograph: Walter Smalling.

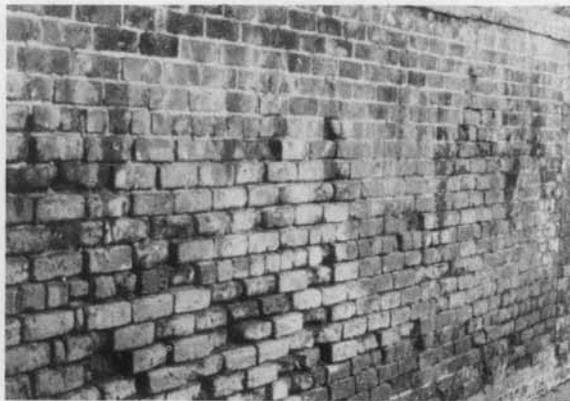
Efflorescence and spalling on brick wall. Photograph: Anne E. Grimmer.

Preservation Treatment: See Poulting, p.44; Water Washing, p.46.

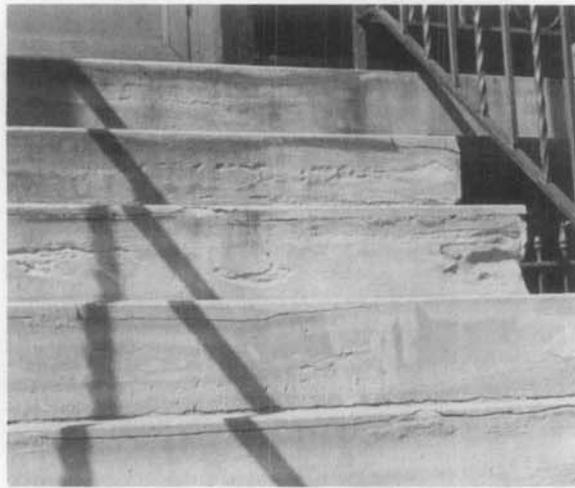
Differential erosion of sandstone steps follows bedding planes of greater and lesser resistance. Photograph: Anne E. Grimmer.

Preservation Treatment: See Replacement/Patching with Like or Compatible Substitute Materials, p.59.

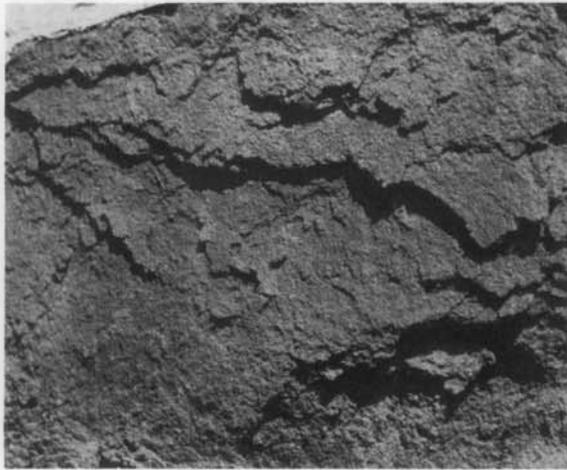
Exfoliation of sandstone. Photograph: Anne E. Grimmer.

Preservation Treatment: See Stucco, p.33; Composite Patching/Plastic Repair, p.50; Mechanical Repair, p.58; Replacement/Patching with Like or Compatible Substitute Materials, p.59.

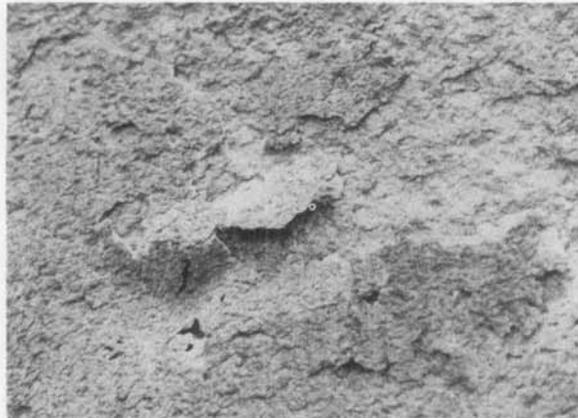
Flaking of granite. Photograph: Baird M. Smith, AIA.

Preservation Treatment: To date, no completely effective treatment has been developed for this condition.

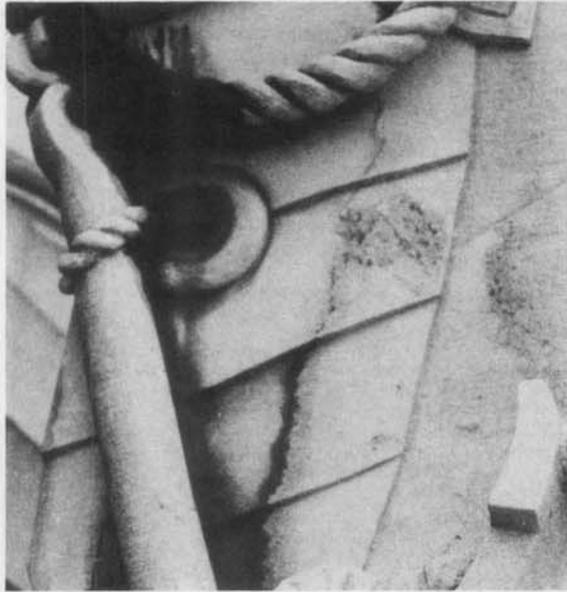
Friability in limestone. Photograph: Anne E. Grimmer.

Preservation Treatment: See Consolidation, p.52.

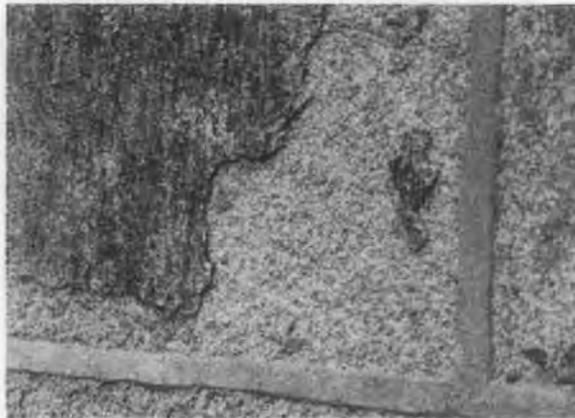
Peeling of granite. Photograph: Baird M. Smith, AIA.

Preservation Treatment: To date, no completely effective treatment has been developed for this condition.

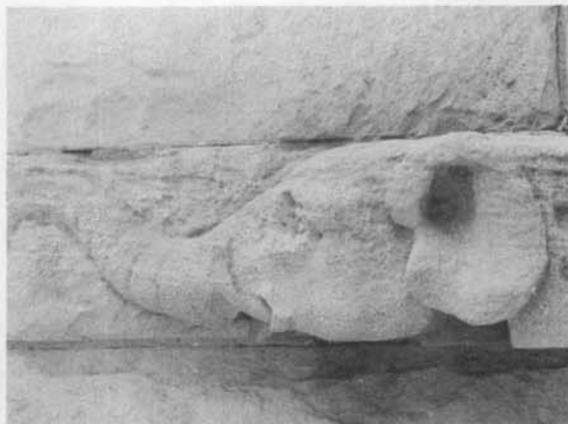
Pitting of limestone. Photograph: John H. Myers.

Preservation Treatment: To date, no completely effective treatment has been developed for this condition.

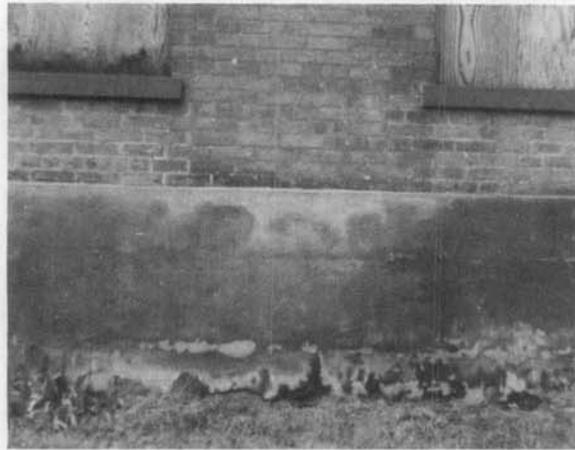
*Rising damp evidenced on parged foundation.
Photograph: John Stubbs.*

Preservation Treatment: See Dampproof Course, p.54.

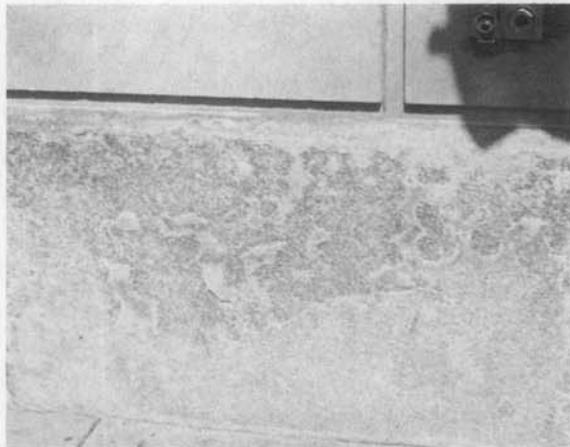
Salt fretting on granite base probably resulting from use of de-icing salts on sidewalk. Photograph: Anne E. Grimmer.

Preservation Treatment: To date, no completely effective treatment has been developed for this condition.

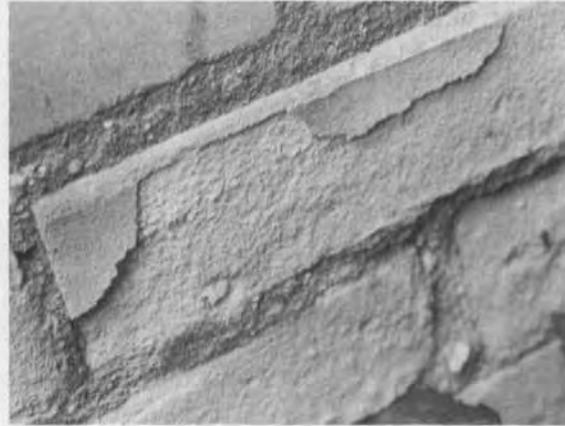
Spalling of brick. Photograph: Susan Dynes.

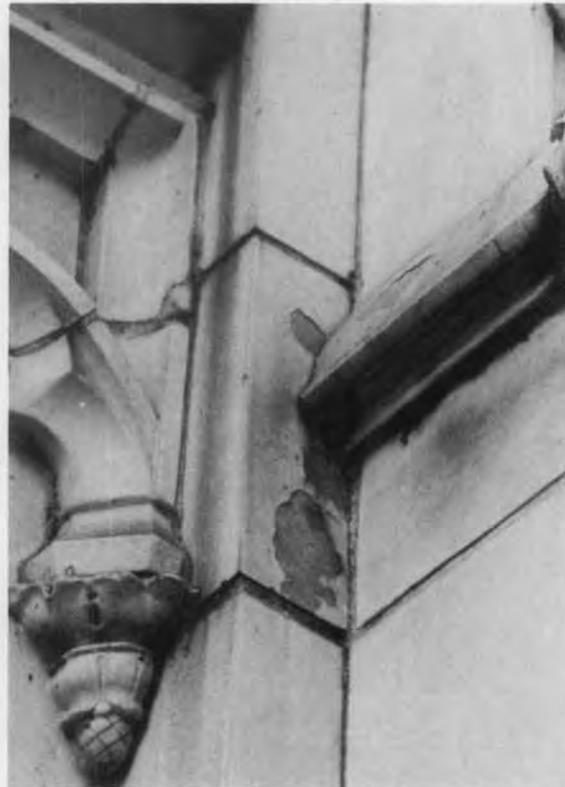
Glaze spalling of glazed terra cotta. Photograph: John H. Myers.

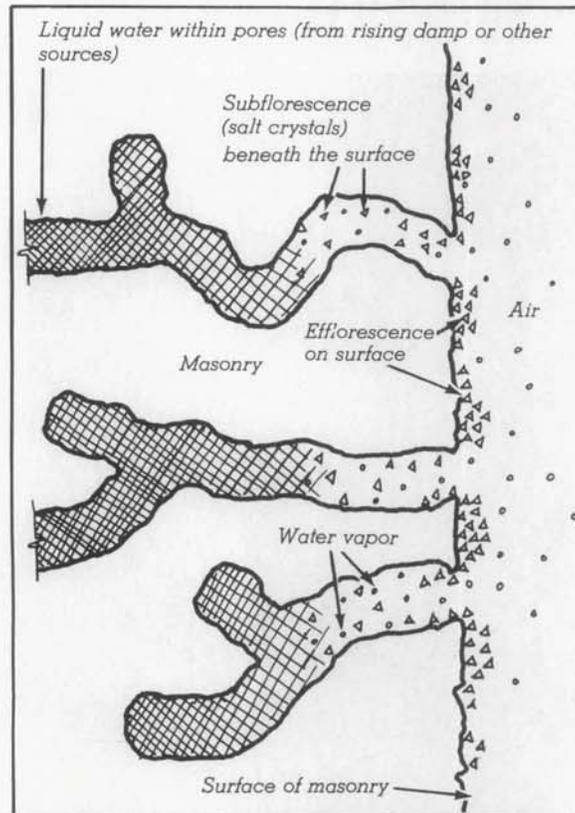
Salts dissolved in water drawn into stone through capillary action evaporate as subflorescence beneath the surface of the stone, and may be evidenced on the stone surface as efflorescence. Illustration: Christina Henry.

Preservation Treatment: See Dampproof Course, p. 54.

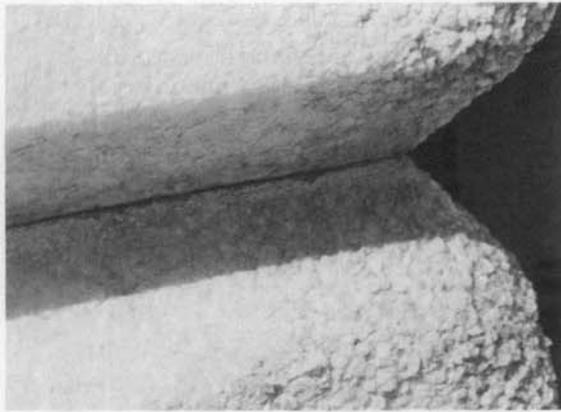
Sugaring of marble. Photograph: Anne E. Grimmer.

Preservation Treatment: See Consolidation, p.52.

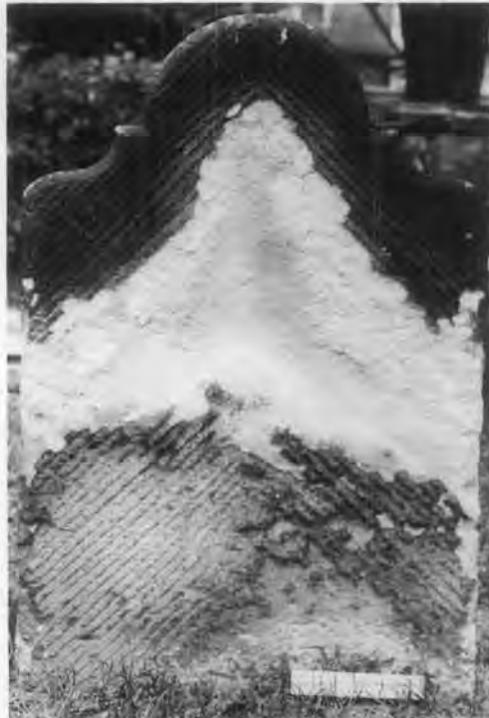
Surface crust on sandstone resulting from dissolution of the stone. Photograph: Erhard M. Winkler.

Preservation Treatment: To date, no completely effective treatment has been developed for this condition.

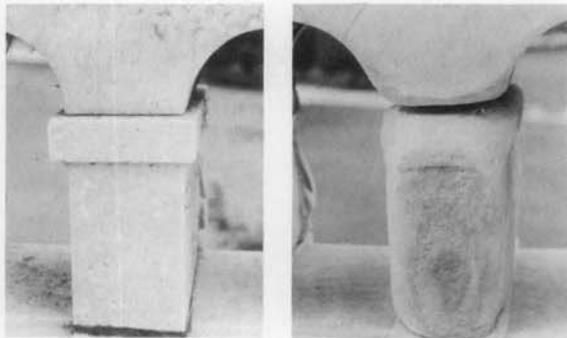
Weathering has reduced the formerly sharp edges and rounded the corners of this marble baluster. Photograph: John H. Myers.

Preservation Treatment: Replacement/Patching with Like or Compatible Substitute Materials, p.59.

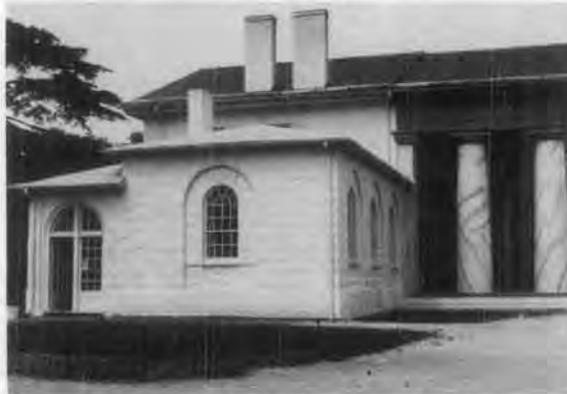
Paint used as a purely decorative aspect to simulate marble on a stucco surface. Photograph: National Park Service.

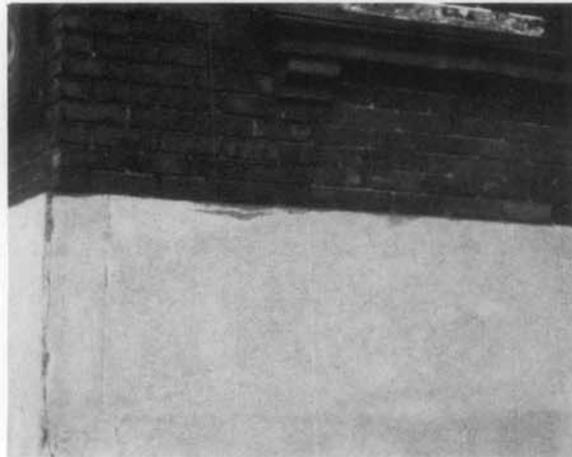
Parging over brick. Photograph: National Park Service.

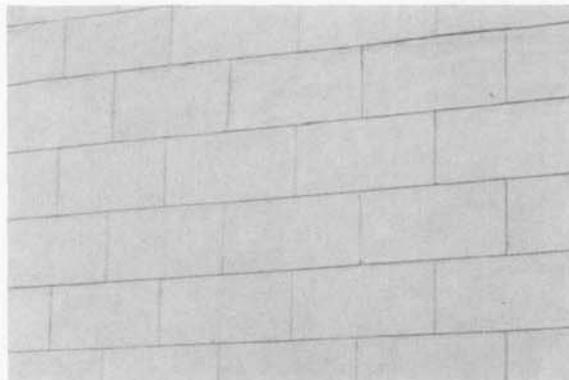
Stucco scored to resemble blocks of stone. Photograph: Anne E. Grimmer.

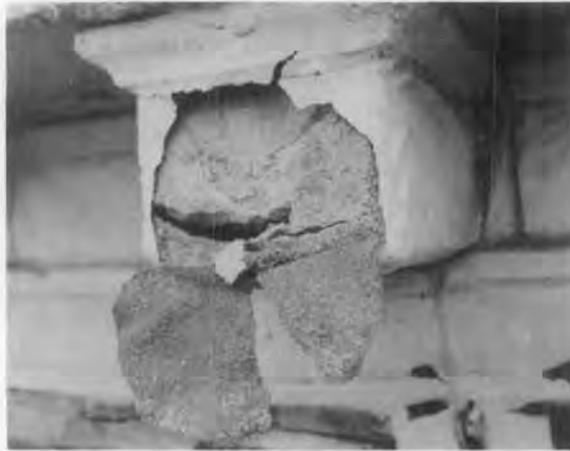
A neoprene coating over a limestone cornice has trapped water (which entered through leaks in the parapet) inside these stone dentils. The built-up water pressure has finally forced the coating to pop off, taking with it pieces of the stone. Photograph: National Park Service.

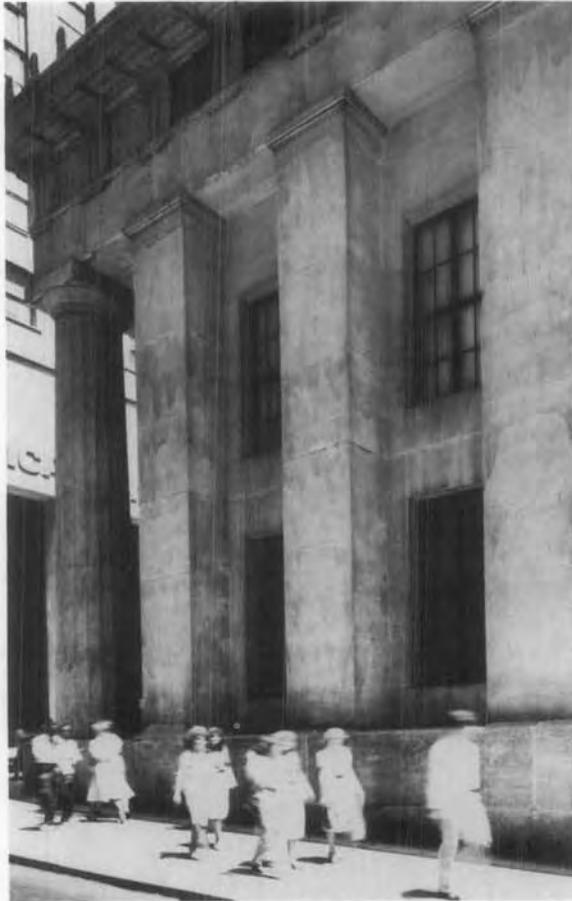
Water-repellent coating improperly applied gives a blotchy appearance to the stonework. Photograph: Walter Smalling.

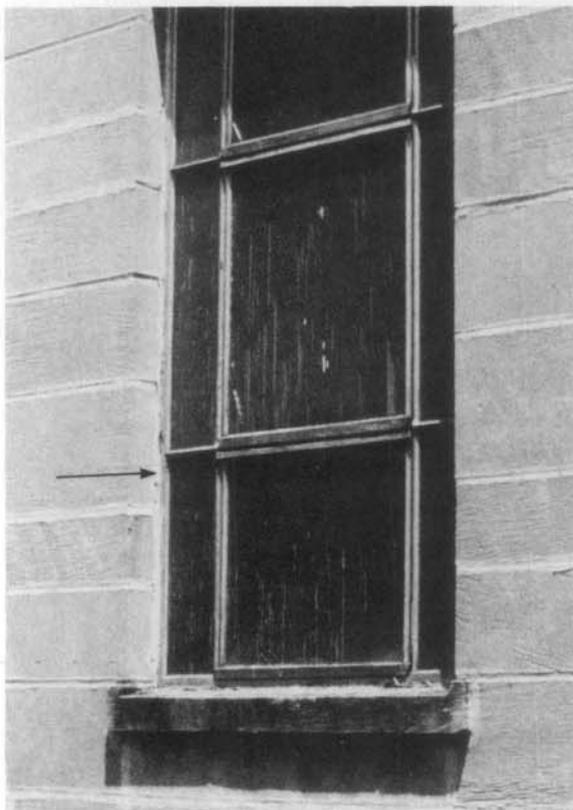
Caulking used as weatherproofing between window frame and masonry wall. Photograph: National Park Service.

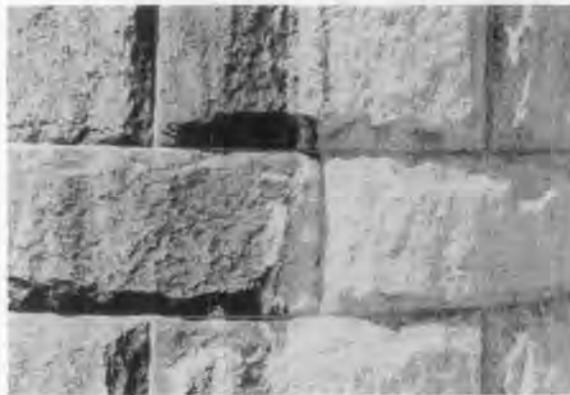
Chemical cleaning to remove urban dirt and pollution from granite without causing damage or abrasion to the surface of the stone.

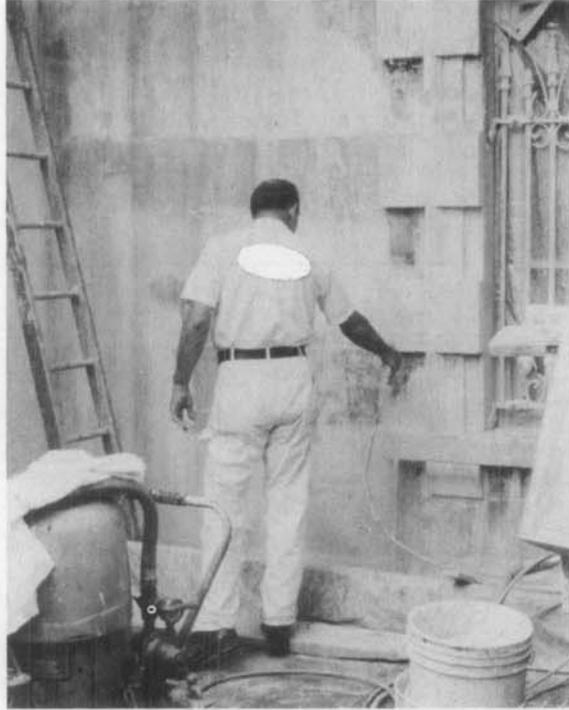
Paint removal from sandstone. Photograph: Baird M. Smith, AIA.

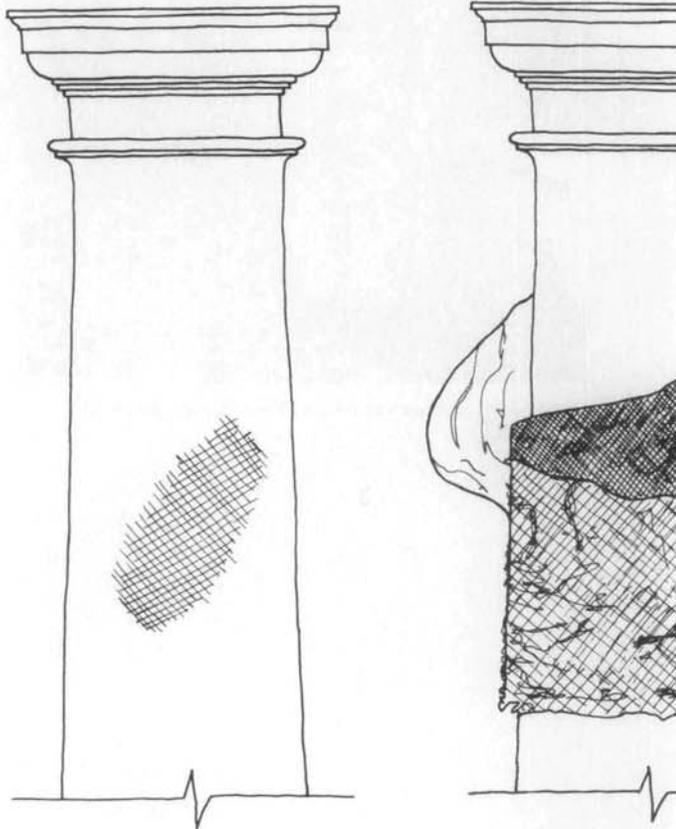
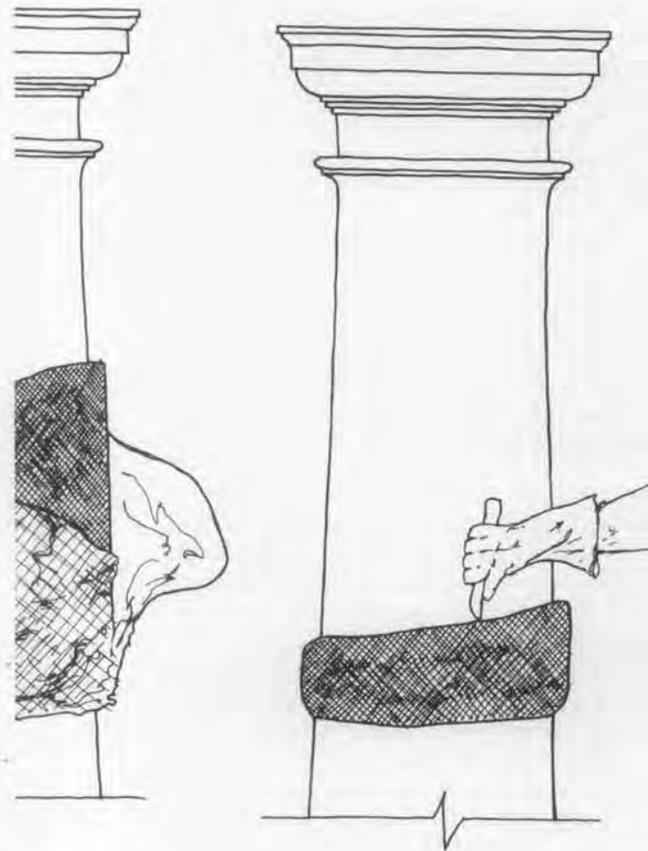
Poultice is applied (saturated with solvent appropriate to remove particular stain). Polyethylene sheet prevents too rapid drying of poultice. After poultice has dried out, the

pack is removed carefully by hand with the aid of wooden spatulas. Finally, the column is rinsed with water.
Illustration: Christina Henry.

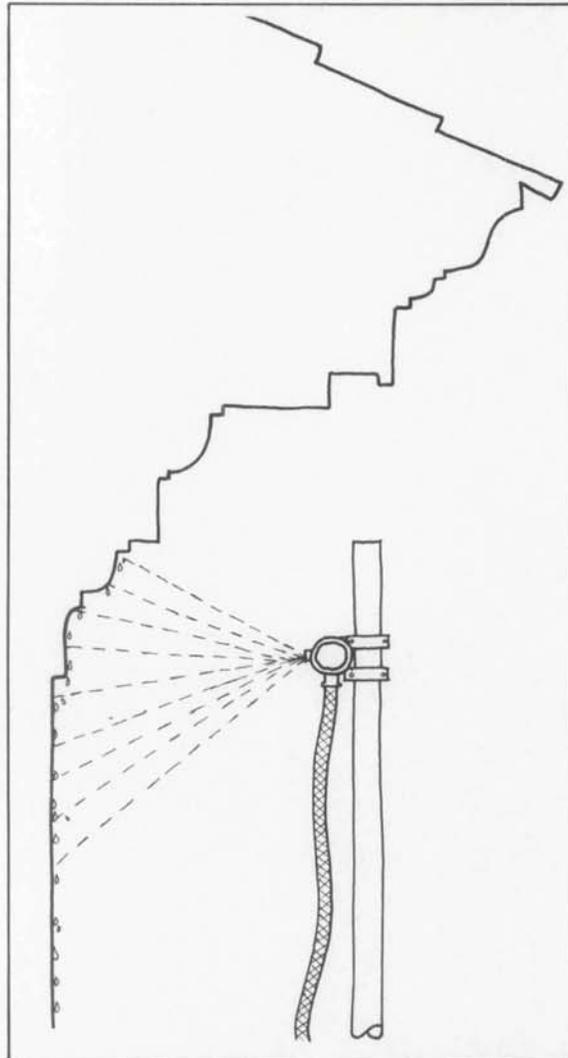
Water washing over an extended period of time using a fine spray or mist to gently soften areas of heavy dirt deposit. Water is sprayed through holes of a pipe or hose suspended from above area being washed. Illustration: Christina Henry.

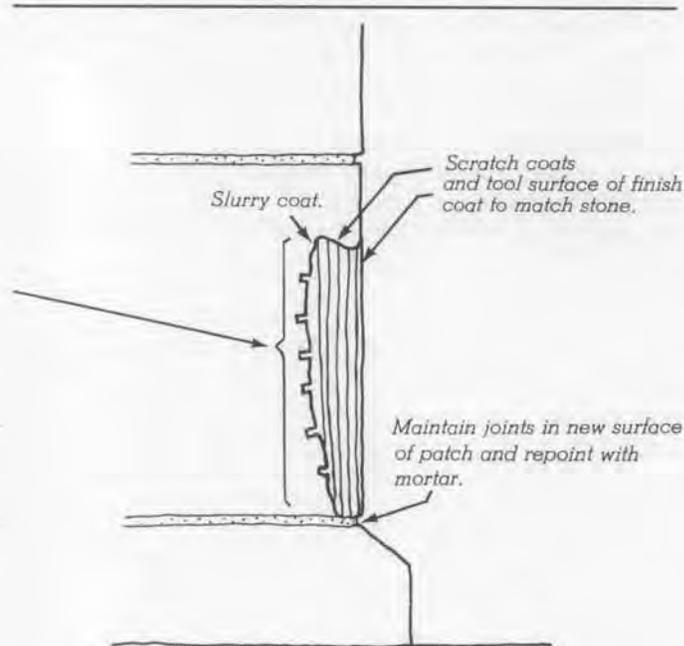
Shape cementitious patching material to match original profile of stone. Maintain joints in new patched surface and repoint with mortar. Illustration: Christina Henry.

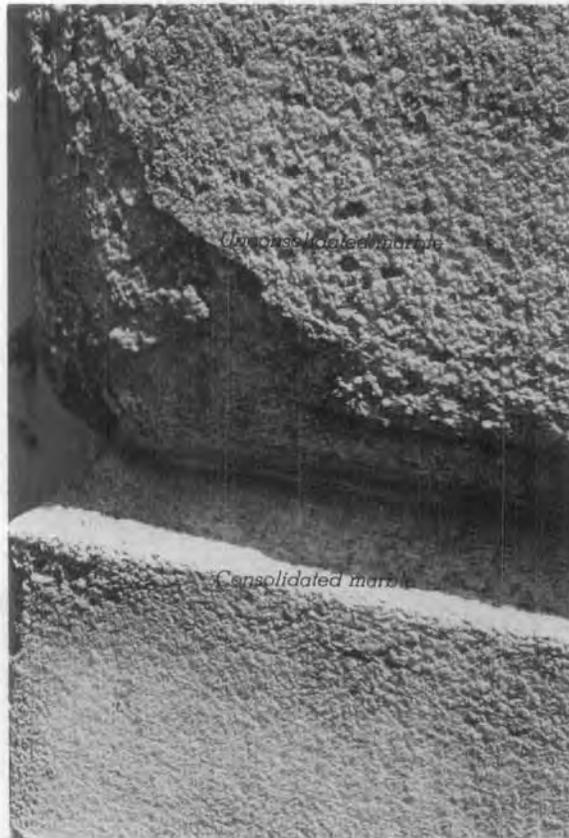
A barium hydroxide consolidant (nearly invisible in the photograph) has been applied here in an attempt to consolidate this sugaring marble. Photograph: Christina Henry.

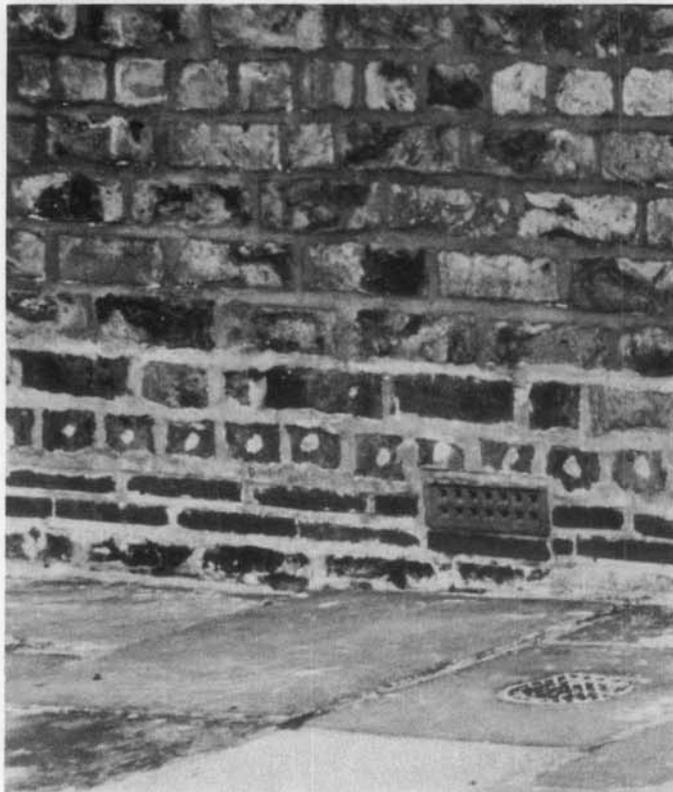
The horizontal row of white dots in the brick headers indicates that a chemical dampproof course has been injected. Photograph: Baird M. Smith, AIA.

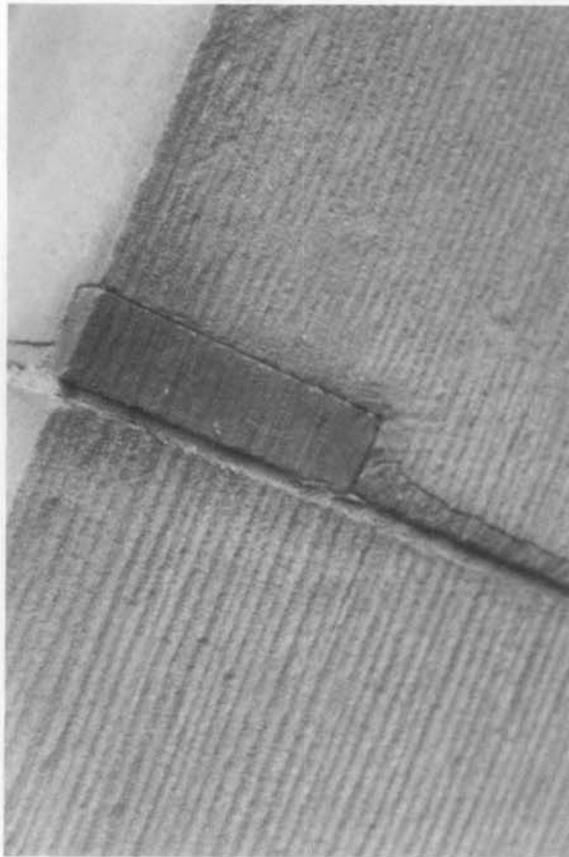
Dutchman repair using sandstone to match original tooled sandstone. Photograph: Anne E. Grimmer.

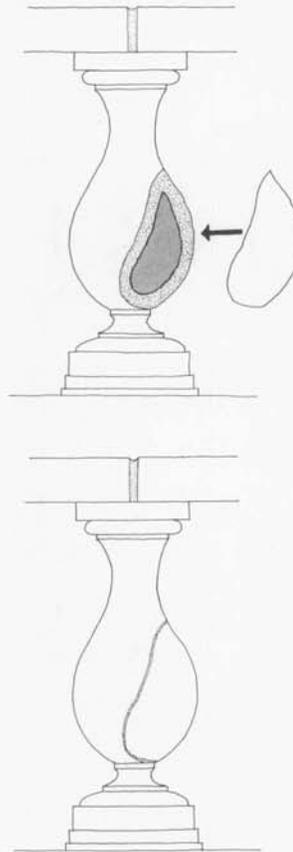
*Epoxy repair of broken terra cotta baluster in which epoxy is applied to the break. The broken piece is reattached and the joint smoothed so repair is not visible.
Illustration: Christina Henry.*

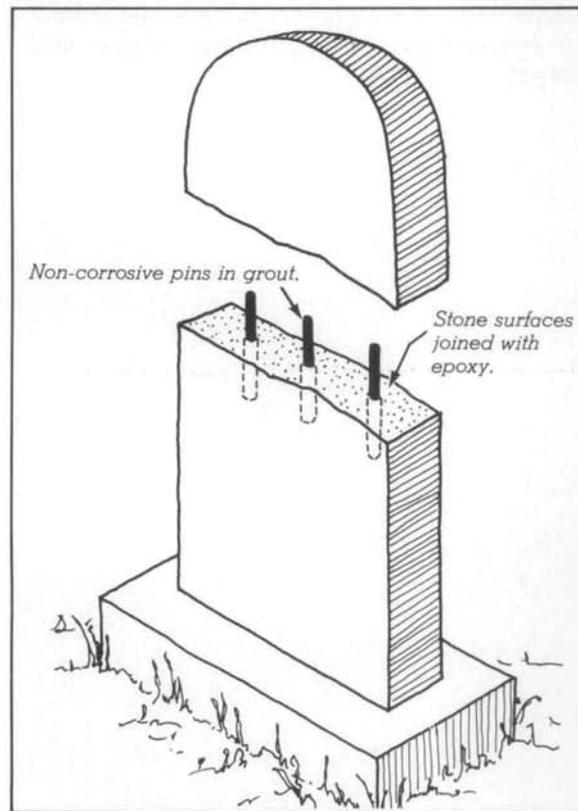
Mechanical repair of detached tombstone using grout and pins. Illustration: Christina Henry.

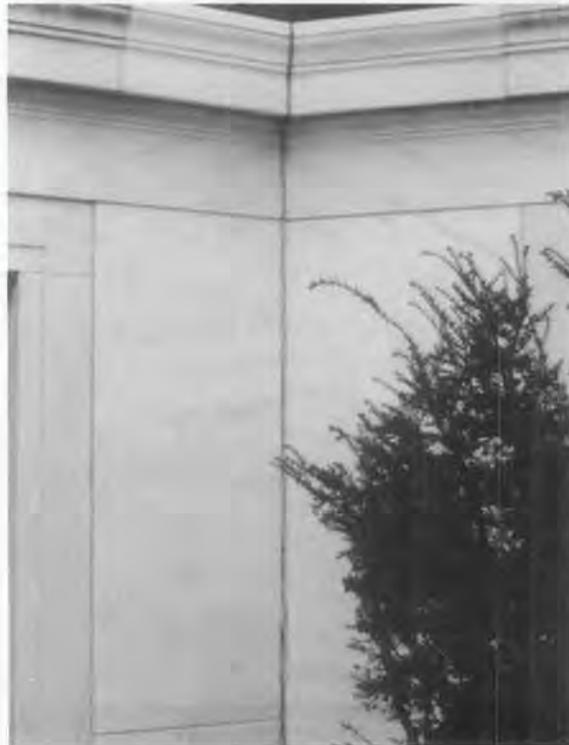
The two sections in the center have been replaced with marble matching the original. Photograph: Anne E. Grimmer.

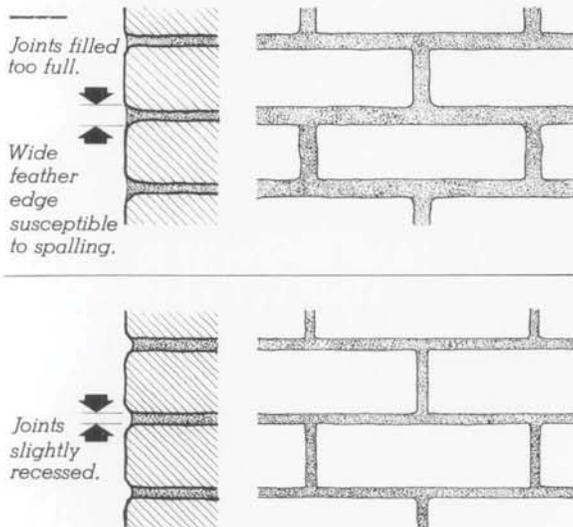
Comparison of visual effect of full mortar joints vs. slightly recessed joints. Filling joints too full hides the actual joint thickness and changes the character of the original brickwork. Illustration: National Park Service.
