## Optical Microscopy Exterior Paint Analysis

**Ailey Young House**  
**Wake Forest, North Carolina 27587-2932**

**Date:** April 20, 2020

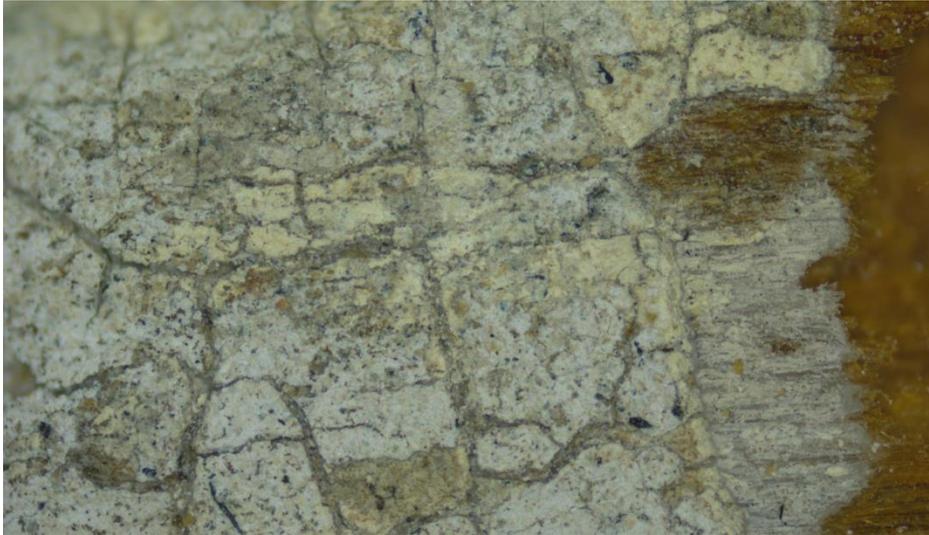
When the wood fragments were examined at 45X magnification prior to cross-section microscopy analysis, it was apparent that there are at least two generations of deeply cracked, grimy paints remaining in samples 1 and 2 from the east side door frame and the south elevation siding, respectively. The wood surface of sample 3 from the window frame is deeply worn and weathered, with only tiny whitish spots of paint, and almost no paint can be seen on the surface of sample 4, from the south elevation siding.

1. East side door frame. Uncast sample with degraded paints on the wood.  
Uncast Sample Photographed at 40X

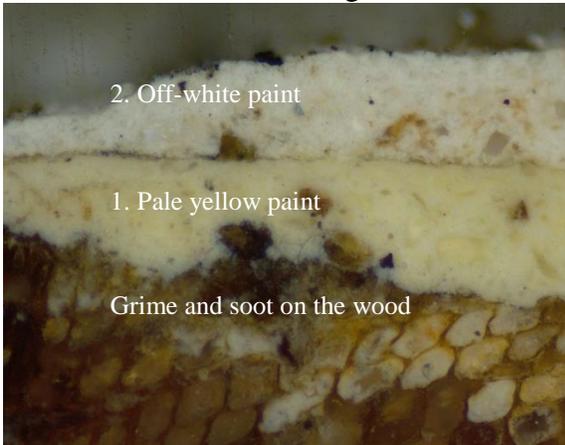
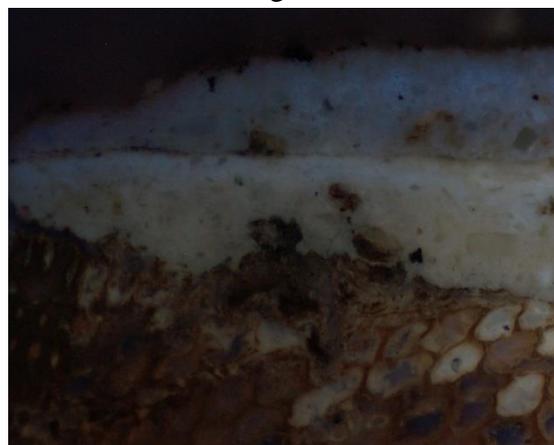
The most intact paint evidence was found in sample 1 from the door frame and sample 2 from the south elevation siding. In cross-section it is apparent that there are gritty accumulations of grime, mold and soot on the surfaces of the wood substrate. This suggests that either these elements were initially left unpainted, or the earliest paints were allowed to completely weather away before repainting. There are two generations of paint on top of the grimy wood substrate. The first generation is an opaque pale yellow paint. This pale yellow paint was allowed to become cracked and grimy before it was painted over with one layer of off-white paint.

wood when the first pale yellow oil paint was applied. There are weak carbohydrate components in the off-white paint (with the fluorochrome TTC) which could be a natural gum additive to the paint. Neither paint layer reacted positively for the presence of proteins. Generation 1 may contain zinc white and white lead, and generation 2 may contain titanium white (a pigment available after about 1920) based on their autofluorescence characteristics.

Cross-section in Visible Light 40X

Cross-section in Visible Light 100X

Ultraviolet Light 100X

There are several alternatives for preserving the paint evidence, but none are ideal as consolidated damaged paints on exteriors will continue to be vulnerable to damage from sun, heat, moisture, and mold. Some possible approaches are listed below:

1. Use a conservation-grade, non-yellowing consolidant like 10% Acryloid B-72 in xylene or ethanol applied with an airbrush and/or low-pressure spray gun to consolidate the flaking paints and provide a protective coating. The disadvantage is that this consolidant will slightly saturate and darken the wood and the paint remnants, and leave a sheen on all surfaces.

2. Use a conservation-grade, non-yellowing consolidant like 50:50 Aquazol 50 and Aquazol 500 in ethanol and water applied with an airbrush and/or low-pressure spray gun to consolidate the flaking paints and provide a protective coating. The disadvantage is that this consolidant is not particularly durable for exterior surfaces, but if applied carefully it will not increase the gloss or saturation of the aged surfaces.

3. Spray on a barrier coat of 10% Acryloid B-72 in xylene or ethanol to protect the paint evidence, and then repaint the building with a pale yellow acrylic or oil paint that has been color-matched to the first generation of paint identified in samples 1 and 2.

4. Erect a shed roof over the building to protect the exterior surfaces and leave the exterior untouched.

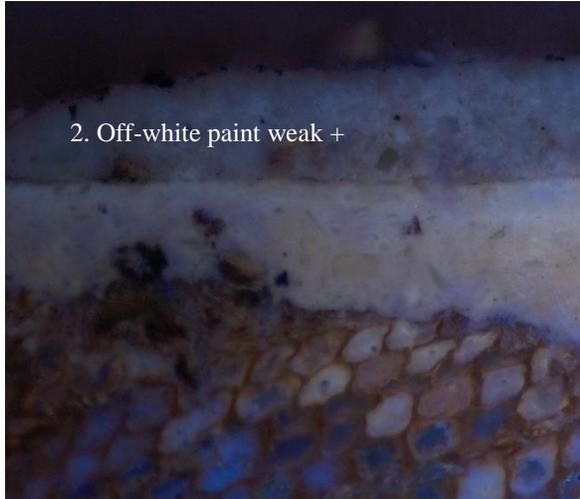
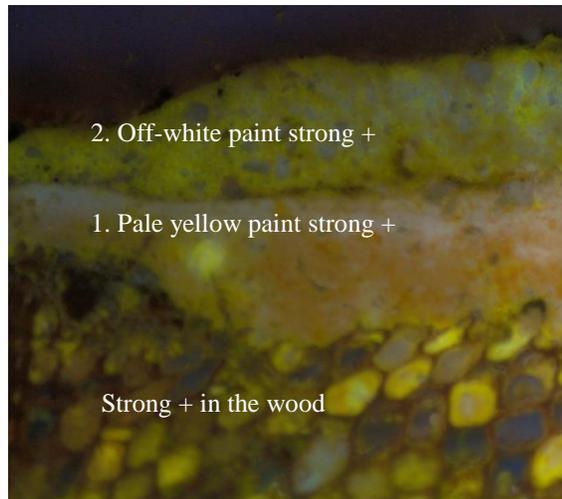
1. East side door frame.

Binding media characterization of the paints in sample 1 shows that both contain strong oil components (with the biological fluorochrome DCF), and there is oil in the wood. This oily material might have been applied separately as a preservative, or it might have soaked into the

UV Light & TTC for carbohydrates 100X  
Weak + reactions for oils in generation 2

UV & DCF for oils 100X  
Strong + reactions for oils in the paints and  
in the wood

2. Off-white paint weak +

2. Off-white paint strong +

1. Pale yellow paint strong +

Strong + in the wood

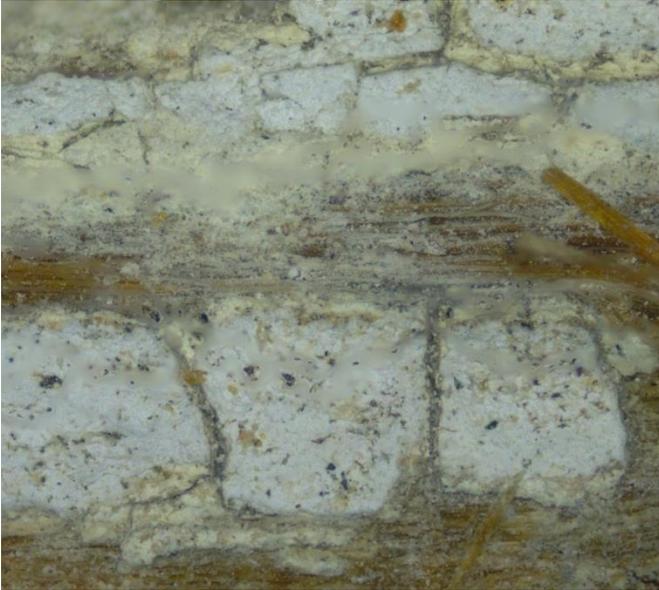
2. South elevation siding. Uncast sample with degraded paints on the wood.  
Uncast Sample Photographed at 40X

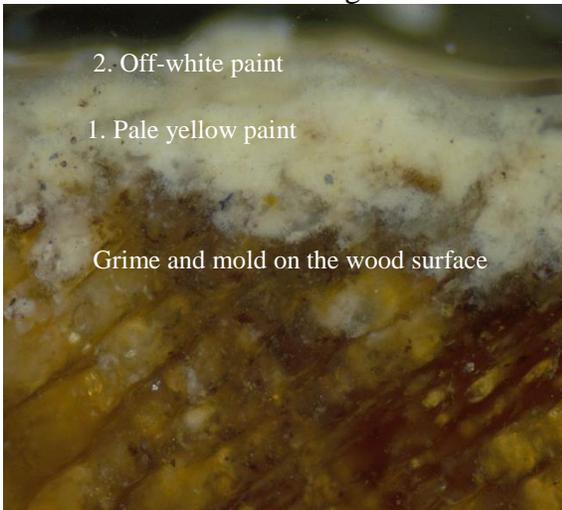
Cross-section in Visible Light 200X

Ultraviolet Light 200X

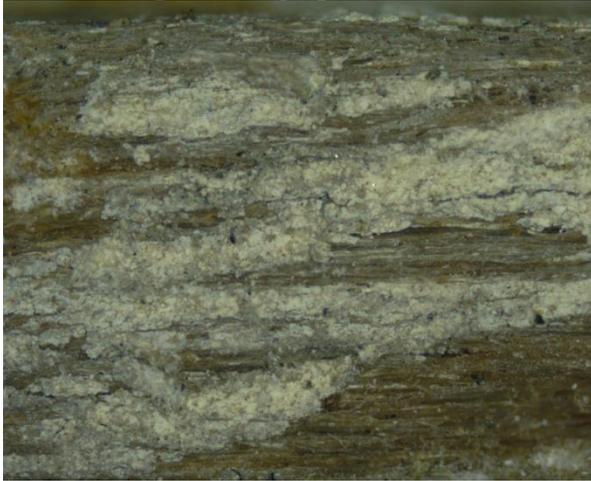
The wood surface of sample 3 is deeply fissured and fibrous, and there are only chalky remnants of off-white paint remaining in the depressions in the wood surface. In cross-section there are small pockets of paint trapped in the wood fibers, but the paints here are particularly fragile and ephemeral.

3. Window frame north elevation. Uncast sample with degraded paints on the wood.  
Uncast Sample Photographed at 40X

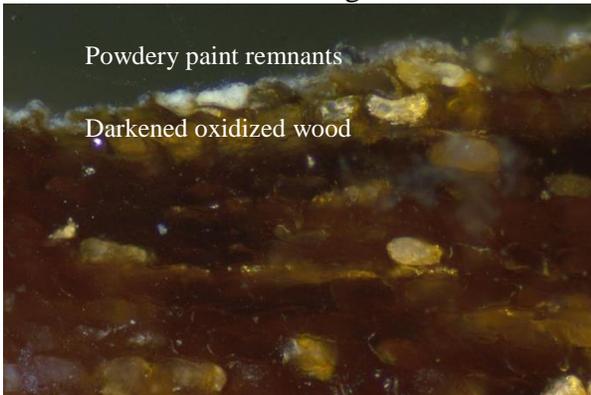
Cross-section in Visible Light 200X

Powdery paint remnants  
Darkened oxidized wood

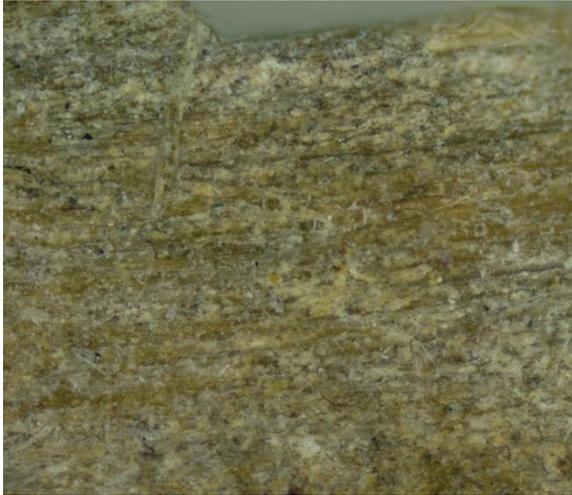
4. South elevation siding (board removed from house).

The paints have been almost completely lost in some areas of south elevation siding, based on the evidence in sample 4. The surface of the wood is powdery and fibrous, suggesting decades of exposure with no protective paint covering. In cross-section the wood surface is darkened and oxidized, with soot embedded in the wood fibers.

Uncast sample with degraded, fibrous wood.

Uncast Sample Photographed at 40X
